REMOVAL ACTION REPORT, RV1

NIAGARA FALLS BOULEVARD SITE

Niagara Falls, Niagara County, New York

October 2020

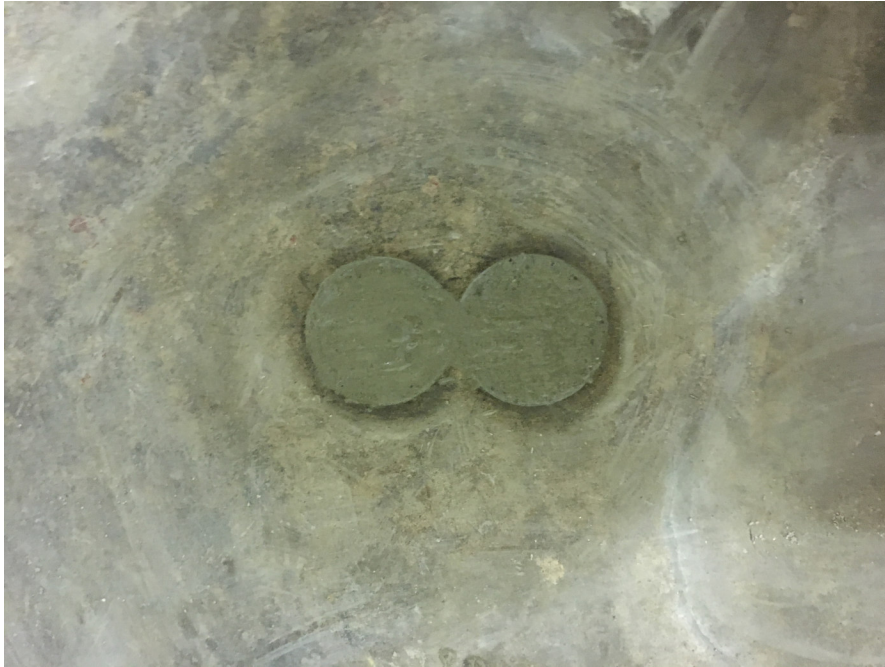
Photograph 5: Core drilling was performed at locations selected by the EPA On-Scene Coordinator (OSC) in GNBC ST-3, GNBC ST-4, GNBC ST-5, GNBC Woodwork Area (WA), and the Church Property utility building from which concrete samples were collected. Locations where core drilling was performed were sealed after collecting concrete sampling.

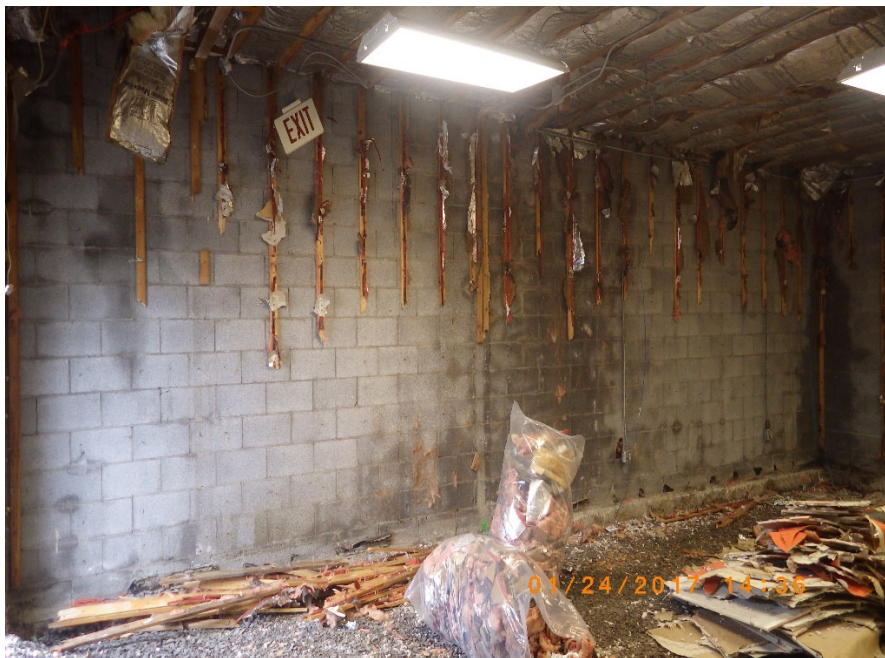
Photograph 6: View of the demolition in the GNBC Office Area prior to excavation. Structural deficiencies that were not building-code compliant were addressed before commencing excavation activities.

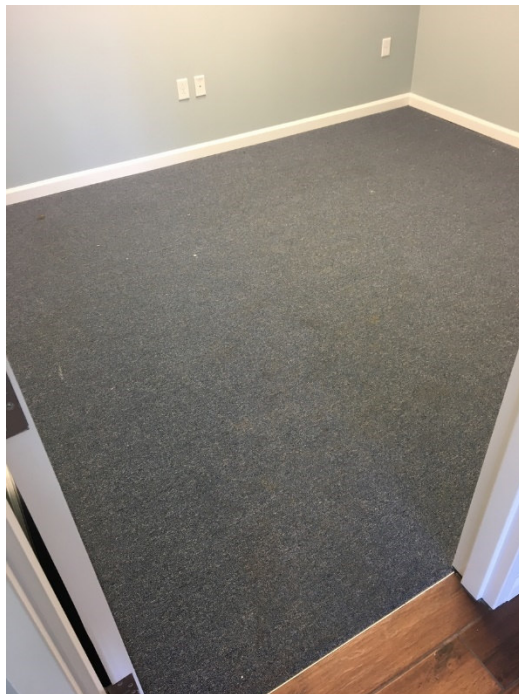
Photograph 19: A construction subcontractor was awarded the contract to rebuild the GNBC Office Area, which included completing concrete cuts, plumbing, carpentry, electrical, HVAC, tiling, carpet installation and painting.

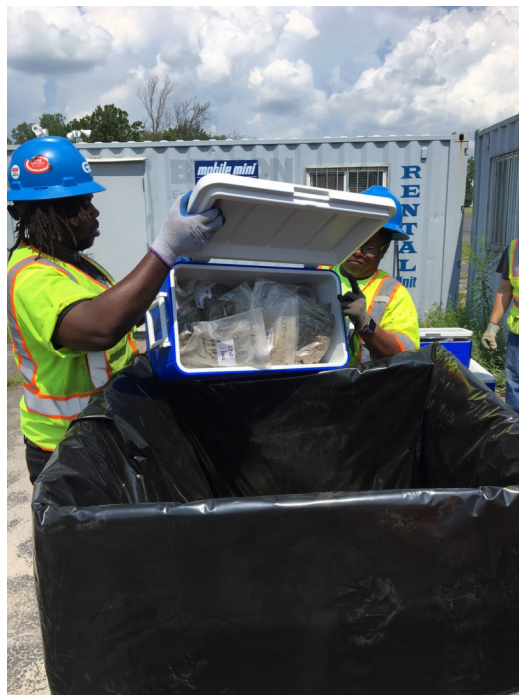
Photograph 20: View of ERRS personnel consolidating leftover soil/slag samples from the May 2017 Removal Assessment sampling event into a lined super sacks. Approximately, 2.25 tons of leftover soil/slag sample material from the May 2017 Removal Assessment event was shipped off-site to US Ecology in Belleville, Michigan.
